TECHNICAL SOLUTIONS ADOPTED FOR REHABILITATION S.P. 6 MOȘNIȚA, TIMIȘ COUNTY

Iacob NEMEȘ, Adia GROZAV, Luminița Livia BÎRLIBA

Abstract: SP 6 Moșnița pumping station is located within the village Moșnița Nouă, and is situated about 1 km from Timisoara, near the county road DN 58 Timisoara - Buziaș. Moșnița Nouă is located on county road linking Timisoara DJ592 Buziaș about 8 km from the center of Timisoara, but recently it almost adjacent to the limits, the partitions area between Moșnița Nouă and the county in last years know a strong municipal development. Distance from other components places of the village is small, and Moșnița Nouă is at the heart of the village territory, linked to other towns with village roads, with Moșnița Veche 1,8 kilometers to the north, Urseni 3 km further south, Albina 3 km east and Rudicica at south-west. Urban development has led to the reduction of actual distance between places components from the nearest buildings Moșnița Nouă and Veche with less than 250 m. Moșnița pumping station, proposed for rehabilitation, works from 1978 year and serves an area of 6320 hectares of agricultural premises of the establishment of draining Moșnița, and presents

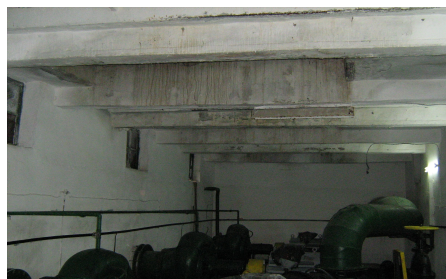
The foundation of pumping station SP6 Moșnița is the type dry shaft, the concrete steel walls present infiltration from the aspiration basin at high levels, but pumping station superstructure due to prolonged operation has a high degree of wear. Category and importance class of works is "D"

Figure 1: The interior of pumping station, infiltrations and aggregates state

➤ The current performance of the station can appreciate; can not be established because there is no measuring device mounted flow into the station. At the no. 4 aggregate yield is estimated at 10%, no. 1 aggregate is defect valve and aggregates 2 and 3 are assessed to have a yield of 40-50%.

It was also aimed at reducing electricity consumption by choosing equipment with high yields and thus reduces the operating costs. The four existing horizontal pumps type BRATES 600 will dismantle and will be replaced with new pumps which are mounted on existing footings.

At pumps replacement will dismantle metal manufactures and fittings on the suction and discharge circuit and replace with new ones.

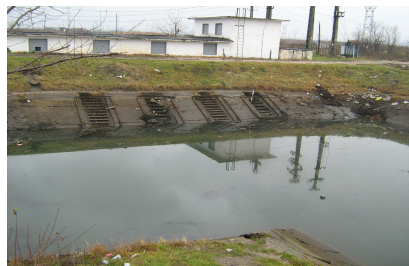
Figure 2: The degraded suction basin of the station

At station has provided the facility of outdoor lighting, extended for another pillar of energy supply in order to feed the grid, and replacement of interior electrical installation. On the draining channel where is located the current basin of aspiration is provide an auto clean grill.

The suction and the discharge basins will be repaired by removing damaged flagstones and casting, on the spot, other flagstones. At the existing building was proposed to replace the existing metal windows with aluminum others of the same size, replace the door with an aluminum access, restoration of existing waterproofing, interior and exterior repairs to plaster, painting interior and exterior, shutter thermo isolation.

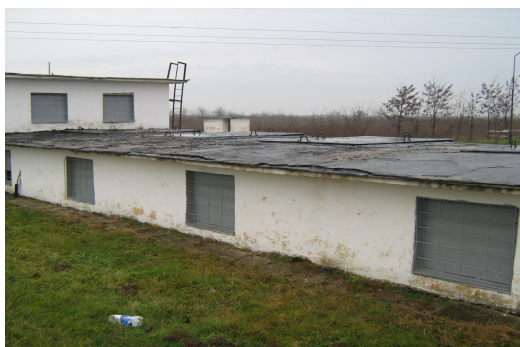
Figure 3: The appearance of the pumping station
