# TRACKING BEHAVIOR OF HYDRAULIC STRUCTURES.CASE STUDY – VALEA DE PESTI DAM JUD. HUNEDOARA

Key words: hydraulic structures, dam, hydrotechnical construction, Valea de Pesti Barrage

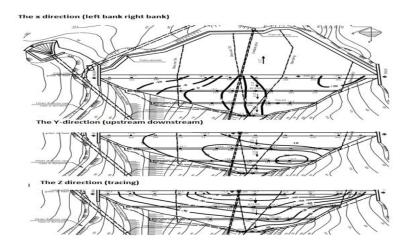
Maximum horizontal displacement of commissioning after 20 years of operation was 21.2 mm, being well below the allowable limit, and this is in the section from the left bank to the canopy.

In general most of the profiles analyzed present plan trips max  $22.3\,$  mm in the direction OX, overall global and relative displacements are small and within the normal behavior of the dam.

Fig. 1 Chart horizontal displacements

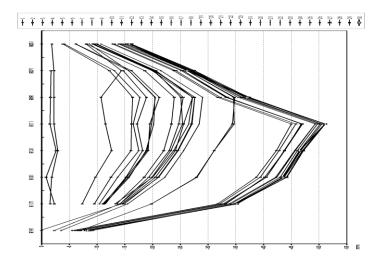
Maximum subsidence is recorded in the canopy , but also three of the downstream berms odds: ASL 813, ASL 796, ASL 782 and plan their distribution is normal considering the asymmetry valley with steep left bank and right bank slower.

For reperii berms downstream of the three phenomena are similar , the continuous appearance of curves showing normal behavior .

Fig. 2. Vertical displacement graph berm

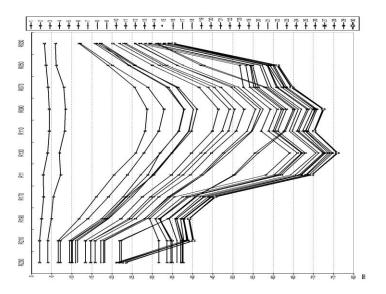
In the period 1973-2005, and are carried out a series of measurements and geodetic 36, generally annual intervals. Distribution along the crest of vertical displacements results in different series of measurements leads to the conclusion that the settlement is proportional to the section height as normal.

Vertical displacements are as normal, maximum canopy - 78.9 mm in the direction of old white where fillings have higher height ( R130 ) .

Fig. 3. Graph displacement vertical canopy
