THE TECHNICAL SOLUTION USED IN THE TERRITORIAL AGRARIAN FOND AMELIORATIVE PERIMETER FROM TIMIȘ COUNTY

Iacob NEMEȘ, Laura CONSTANTINESCU, Luminița Livia BÎRLIBA

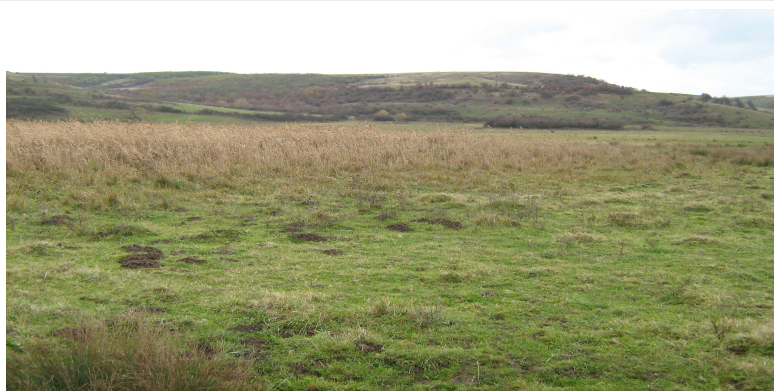
Fig.1 Infection with reedbeds and woody vegetation of grassland from the perimeters of improvement

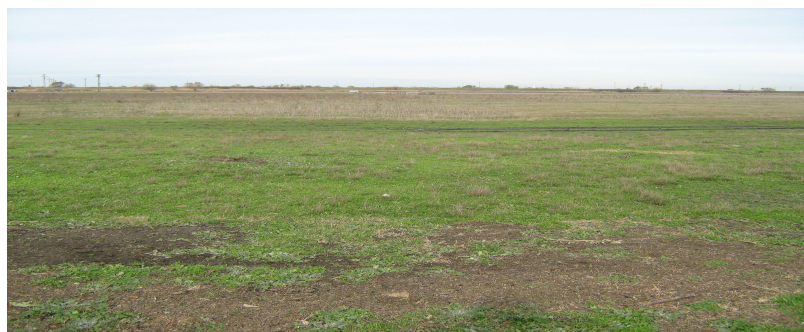
Fig. 2 Lack of consistency of the reedbeds from the perimeters of improvement

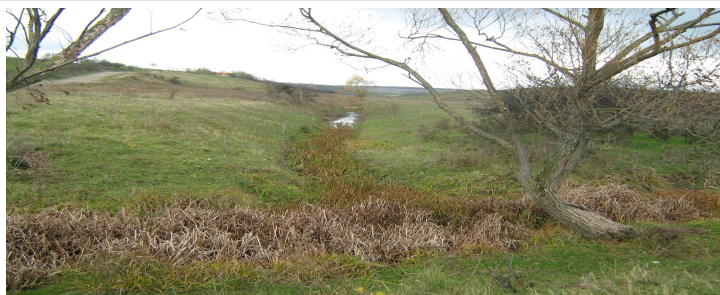
Fig. 3 Infection with vegetation of natural outlets from the perimeters of improvement

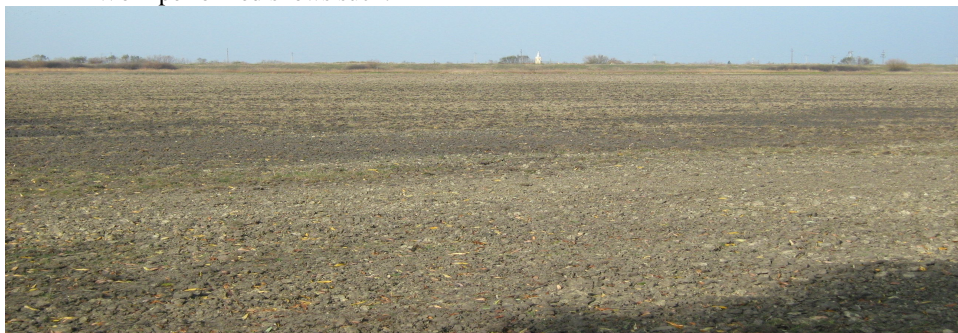
Fig. 4 Modeling of land in the improved perimeters

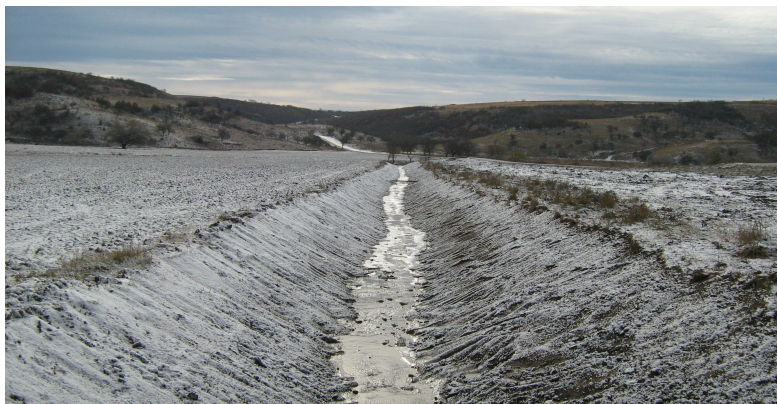
Fig. 5 Natural outlet reassembled

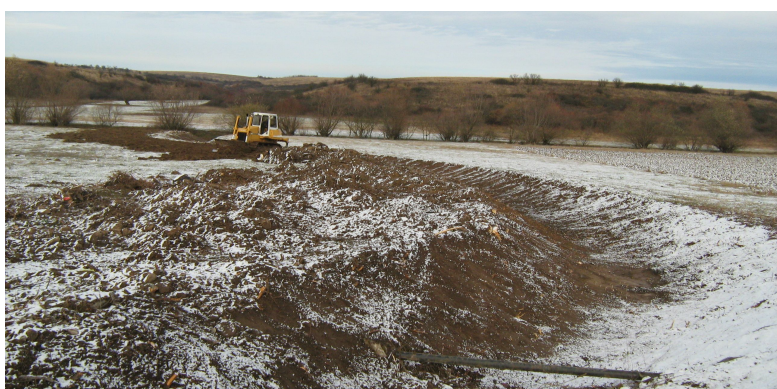
Fig. 6 Discharge of water channels executed in improved perimeters
